RETRIEVAL OF BROKEN GINGIVAL FORMER: A CASE REPORT

Department of Periodontics, St. Joseph Dental College, Eluru, India

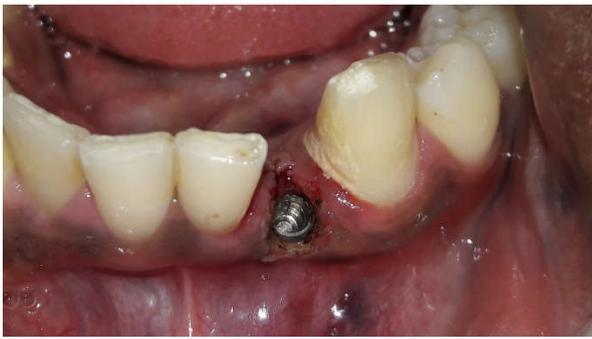
At 3 months visit, a radiograph was taken to ensure proper osseointegration. Then stage 2 surgical site was performed by opening the surgical site using diode laser (BIOLASE EPIC 10) under local anesthesia. Cover screw was removed using a torque driver. During the placement of the gingival former, due to excess torque, the gingival former got fractured (Fig 1). On radiographic examination, there was fracture of the gingival former in the lower third region (Fig 2).

Fig 1 Broken gingival former

A low speed rotary motor with a carbide bur in reverse rotation and with continuous saline irrigation was used to retrieve the fractured gingival former. The tip of the carbide bur was placed on the head of the broken gingival former and a part of it was trimmed to create a trough between the gingival former and the implant, without damaging the implant threads. Then ultrasonic scaler with sub-gingival scaler insert was placed in the gap created between the implant and the broken fragment and is slowly vibrated to loosen the screw. The loosened fragment was removed with the help of a high volume suction (Fig 3). The cover screw is then replaced over the implant to ensure proper healing of the operated site.

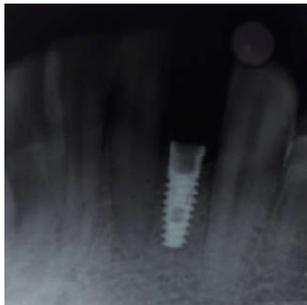
Fig 2 Screw fragment in radiograph

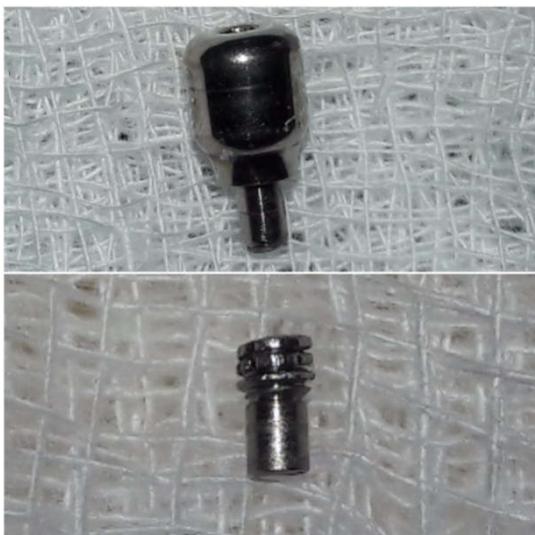
Fig 3 Retrieved fragment
